St Catherine's Hill and Town Common Management Plan

HYDROLOGICAL APPRAISAL

Project: Hydrological Appraisal

Report date: Revised 26 October 2010

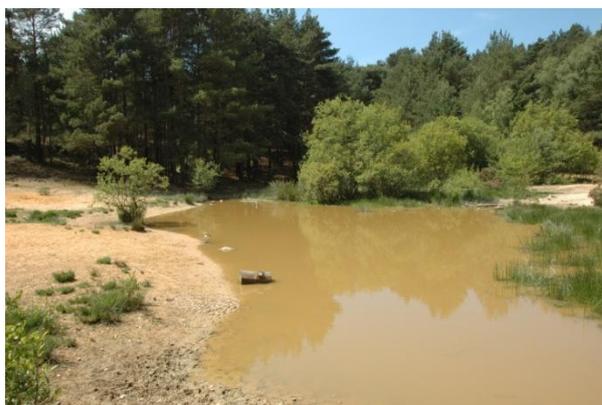
Rainwater falling into the main quarry appears to be retained initially as a pool and which reduces in depth during the summer (**Figure 11**). We assume that this water is perched over pipe clay layers or perhaps over the underlying less permeable Branksome Sand. Water in

Fig. 11 The pool in the summit quarry

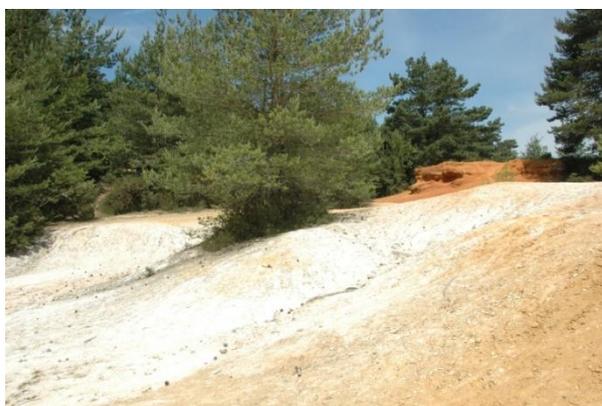
Rain falling on the Terrace Gravels will infiltrate quickly where the gravels are coarse sandy with a high permeability. However, pipe clay layers (**Figure 12**), finer sandy and cemented layers will affect the rate of downward percolation and the extent to which any perched water tables will occur (where water sits upon an impermeable layer).

Fig. 12 Thick layer of 'pipe clay' within the gravels in the quarry

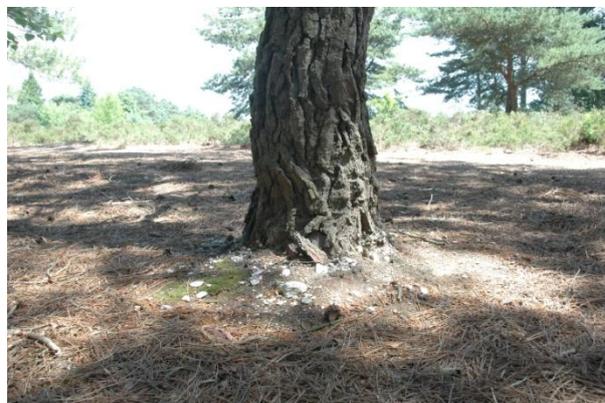
Heavy rain fall would result in rapid saturation of surface soil layers and cause water to move sideways by surface flow, especially on slopes. Given sufficiently heavy rain, sheet flow would result in the washing away of the leaf litter leaving the bare mineral soil liable to erosion. This process would explain why some trees, especially on the gravels, appeared to be grow out of small mounds about 10-25cm high, the surrounding soil having been washed away leaving a lowered land surface (**Figure 15**). Very often these small mounds would have flint accumulations on their downslope sides and we suggest that this results from water running down the tree stems (stemflow), exposing the gravel deposits and washing out of the flint stones from the adjacent soils.

Fig. 15 Pine tree on mound possibly indicative of past surface erosion

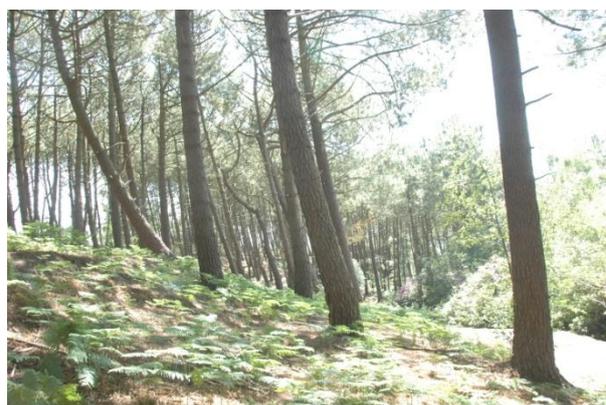
Many pine trees on slopes exhibit signs of instability with leaning stems, soil deposition around the upper sides of the stem bases and areas of erosion around the lower sides of the stem bases. Reasons for this remain speculative, and could result from groundwater pore pressure causing downward movement of soils which, along with possible sheet and localized erosion and the predominantly westerly winds could result in tree instability. In addition, the very weight of the trees themselves could cause the trees and their immediate substrates to move downslope by perhaps 1-2m. This effect could increase as the trees increase in weight and height and so alter their weight distribution.

Fig. 16 Leaning pine trees

We recommend that further investigation of these trees should be undertaken on health and safety grounds and an assessment of their likely life span as healthy trees. Removal of any dangerous trees could result in small areas of heathland establishment within the pine woodland areas creating 'wood heath'. Given small areas, the resulting changes to surface and ground water flow would be small.

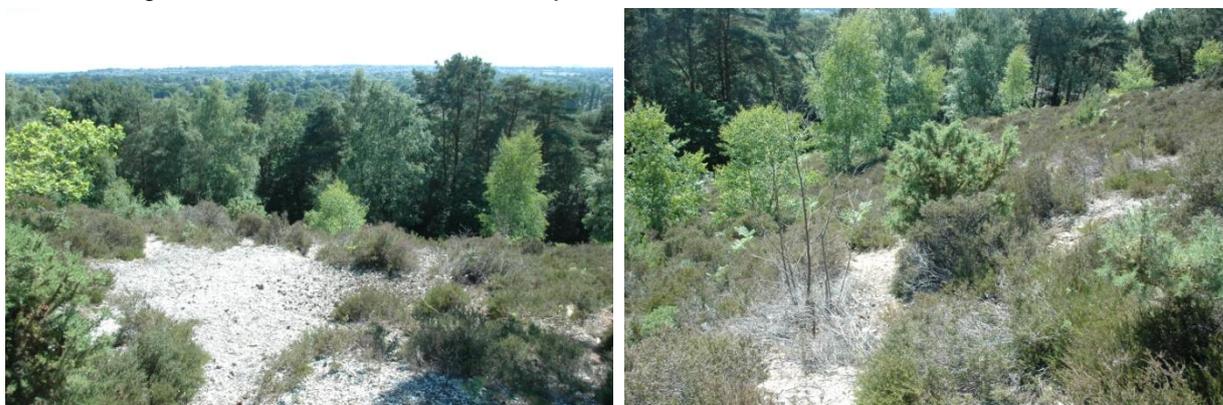
Fig. 17 Exposed gravel and short erosive runnels on slopes with heather

We observed that (close to the old rectangular reservoir) the gravel soils lacked topsoil and that water runnels had developed running down slope and passing between heather plants. It appeared that sheet wash was being partly impeded by the heather plants and which partly concentrated the flows into bare flinty runnels (**Figure 17**). About half way downslope, these runnels ceased and we conclude that flow having lessened, that water could now percolate directly into the ground.
