St Catherine's Hill and Town Common Management Plan

HYDROLOGICAL APPRAISAL EXECUTIVE SUMMARY

Project: Hydrological Appraisal

Report date: Revised 26 October 2010

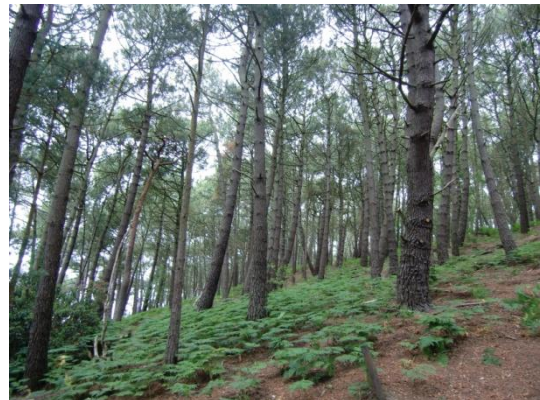
Pine woodland at St Catherine's Hill

We have seen some evidence of the effects of surface washing below the existing pines leading to a slightly lowering of the sloping land surface; also the accumulation of material (such as upslope of tree stems). We assume that this slight erosion may arise when heavy storms have washed away leaf litter and exposed the sandy soils to surface washing. Heathland establishment would give better ground cover and reduce the potential for such erosion however, care would be needed to prevent such erosion in the time period between felling and heathland establishment.

We have noted that many of the tall mature pines have stems sloping back towards the hillside and that slight erosion on the downslope side of the tree stems may be destabilising some of the trees. We recommend that an assessment of their health and safety should be undertaken. Removal of any unsafe trees may provide opportunities for heathland regeneration in those locations.
