St Catherine's Hill and Town Common Management Plan

HYDROLOGICAL APPRAISAL

Project: Hydrological Appraisal

Report date: Revised 26 October 2010

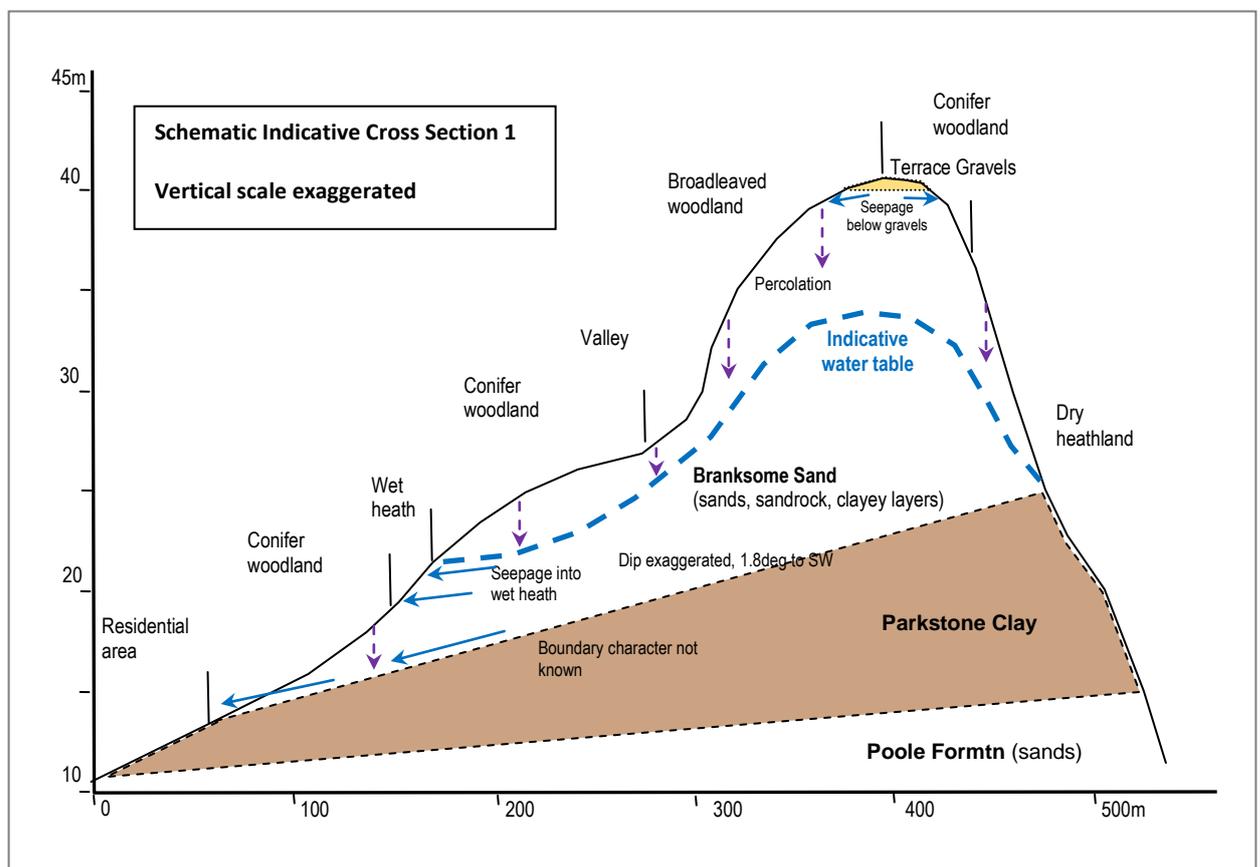
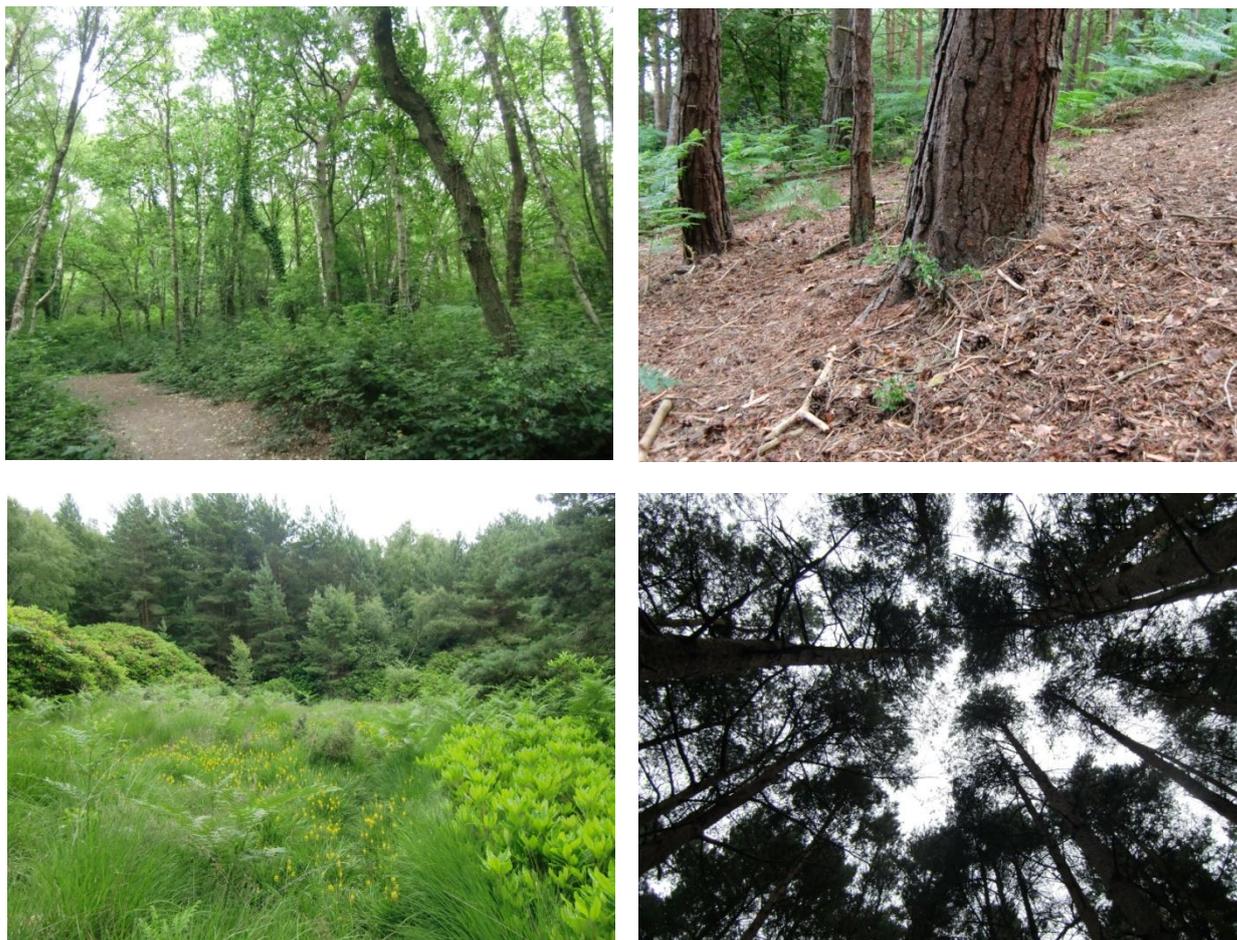
Fig. 20 Study area 1

This area in the southern part of the site opposite Sandy Lane (**Figure 20**) occupies a broad valley feature and has a large area of open coniferous woodland with an often dense broadleaved understorey on gentle slopes and with some pure pine woodland on smaller areas of steeper slopes. The pure pine woodland has only a sparse layer of bracken and some trees are seen to lean towards the valley side and have soil accumulation and erosion above and below the tree stems.

The dip on the surface of the Parkstone Clay is 1.8 degrees to the south west.

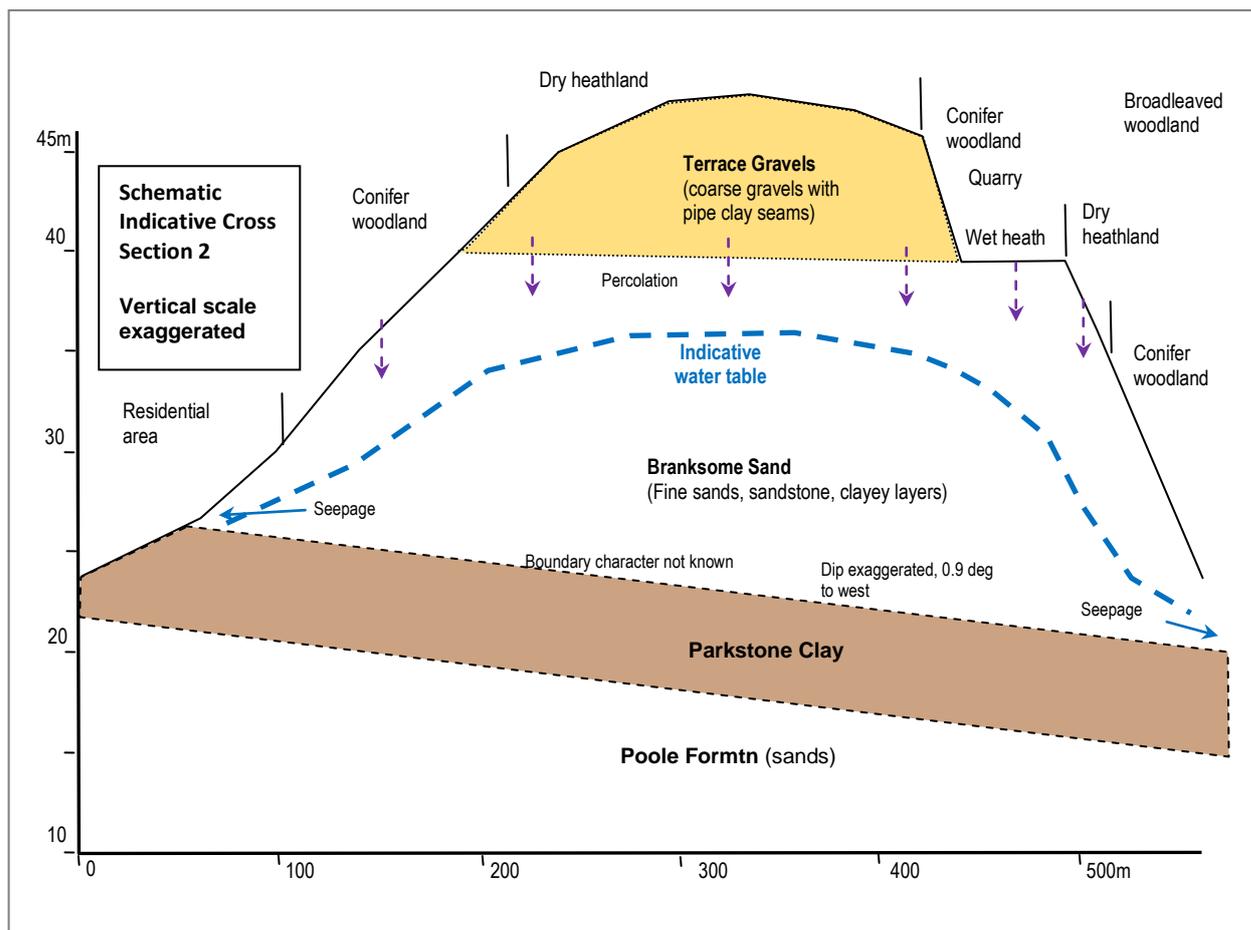
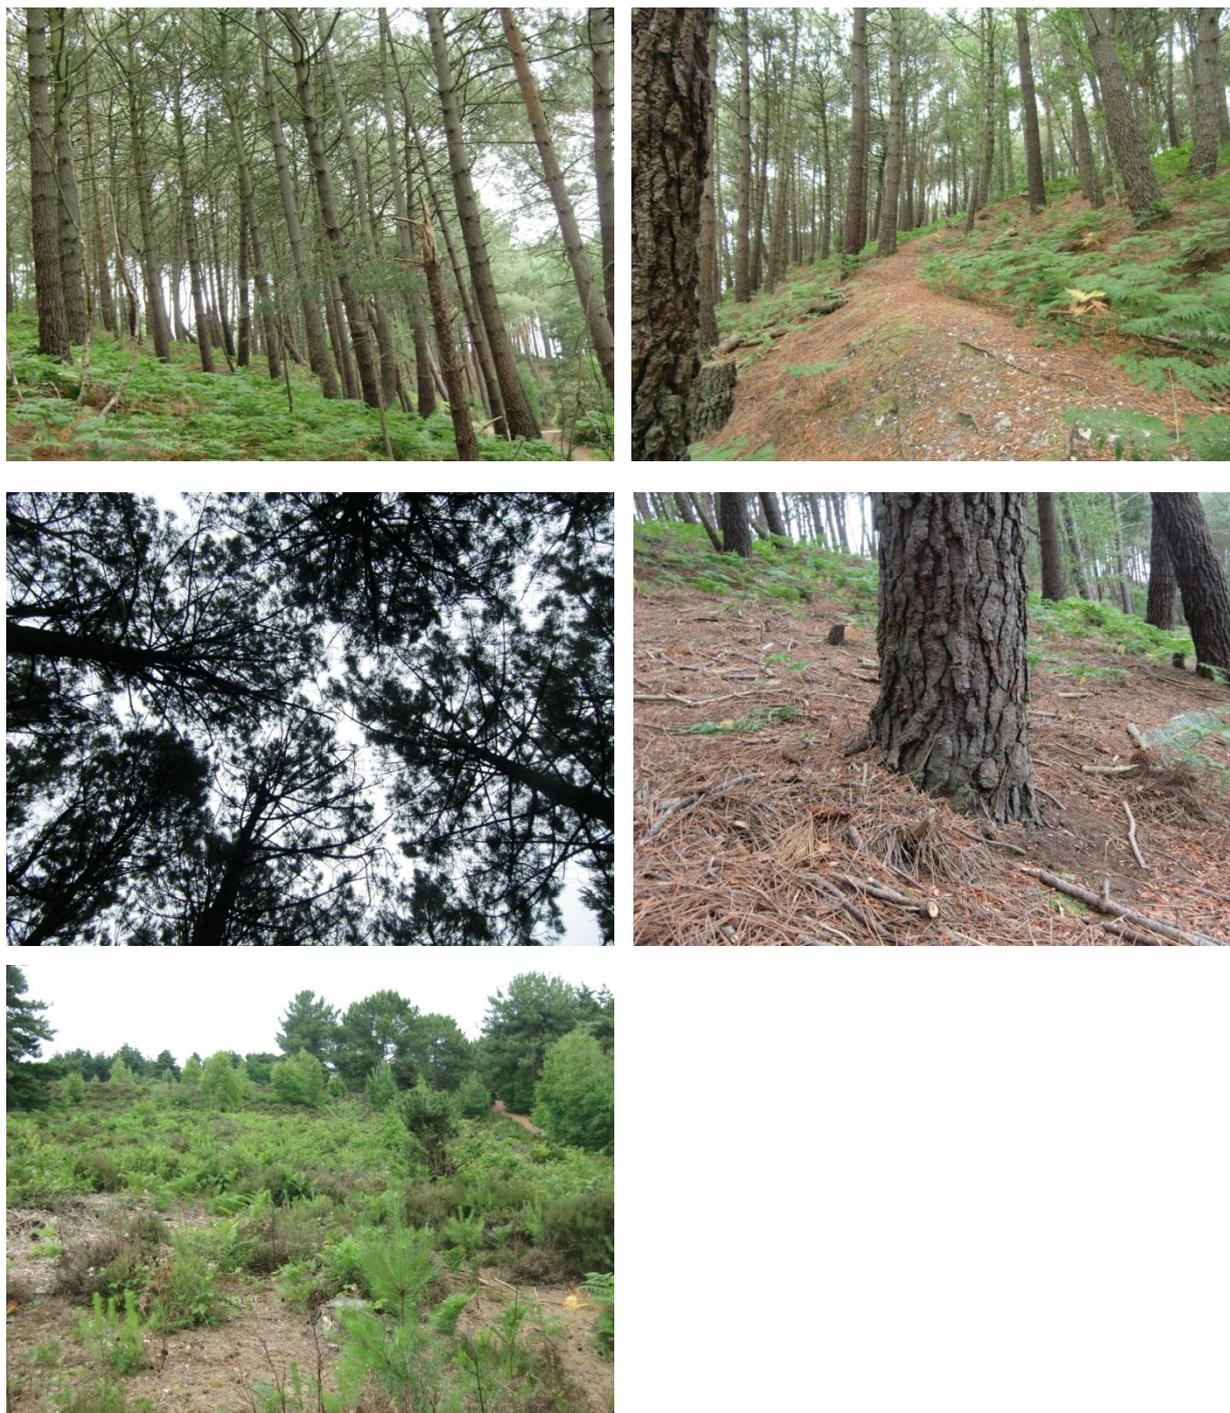
Fig. 21 Study area 2

This area (**Figure 21**) is approached via the track from the top of Marlow Drive and comprises a valley feature cut into the hillside with moderately sloping valley sides covered in pine woodland with only a sparse layer of bracken below. Many of the pines have a distinct lean towards the hillside with the typical signs of soil accumulation and erosion above and below the tree stems. The pine canopy is also very open and the branches only poorly leafed.

The dip on the surface of the Parkstone Clay is 0.9 degrees to the east.

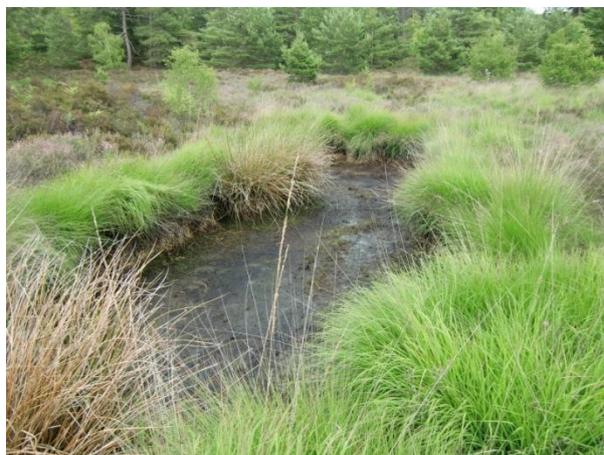
Parts of the slopes are covered in pine woodland and there is an area of wet heath / mire in the valley bottom. A pond has been cut into the wet heath area which was muddy at the time of the visit but appeared to have held water earlier (**Figure 22**).

Fig. 22 Pond and wet heath in study area 3
